**Coal Combustion Residue Impoundment
Round 9 - Dam Assessment Report**

*H.L. Spurlock Power Station
Spurlock Ash Pond
East Kentucky Power Cooperative
Maysville, Kentucky*

Dewberry & Davis, LLC
Fairfax, Virginia

Under Contract Number: EP-09W001727
December 2011

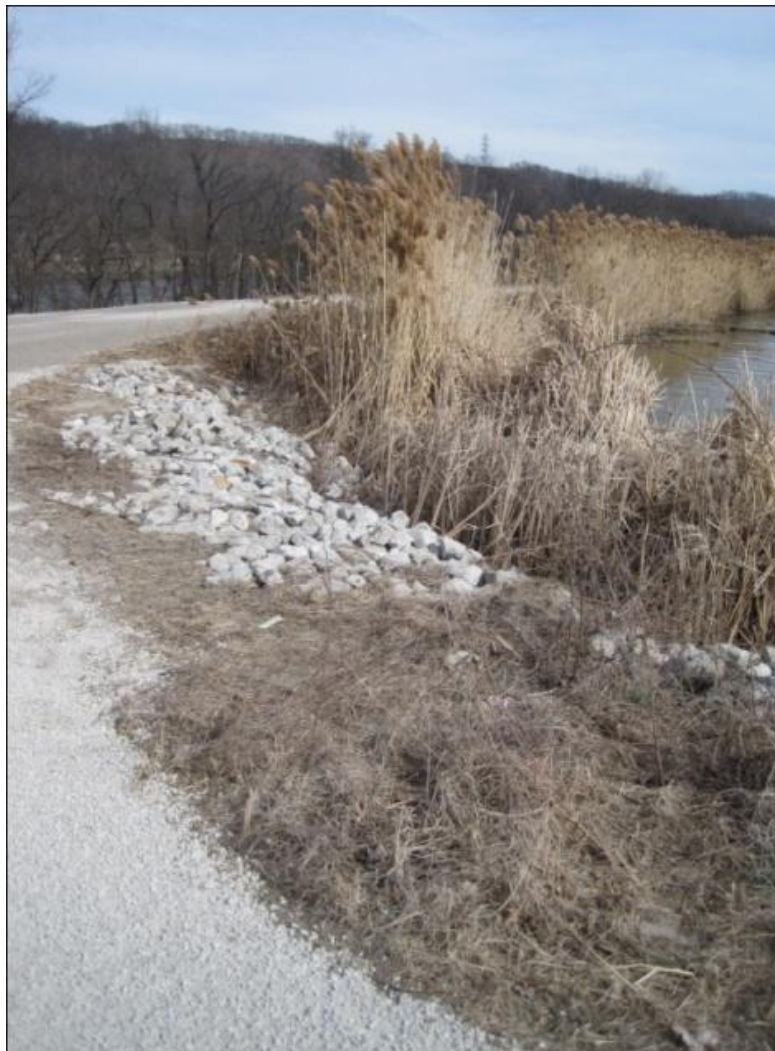
The crest of the Ash Pond had no signs of depressions, tension cracks, or other indications of settlement or shear failure, and appeared to be in satisfactory condition at the time of this assessment. Typical conditions of the Ash Pond's North, South, East, and West crests can be seen below in Figures 5.2.1.1 through 5.2.1.4, respectively.

Figure 5.2.1.1: Looking NE from W Crest at N Crest Typical Conditions (See Top Left Corner of Figure)

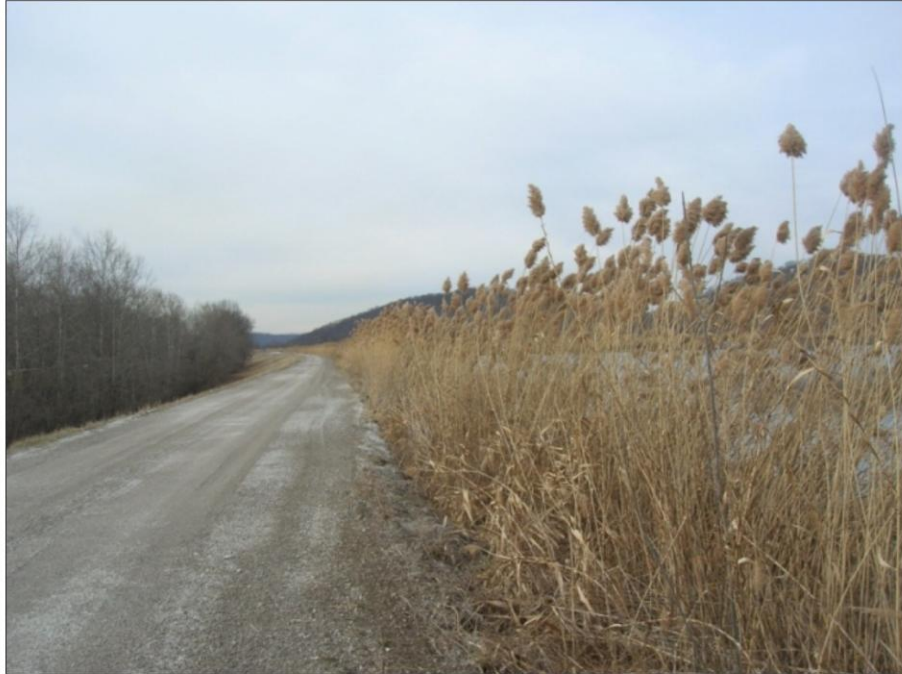
Figure 5.2.1.2: Looking down S Crest; Typical Conditions

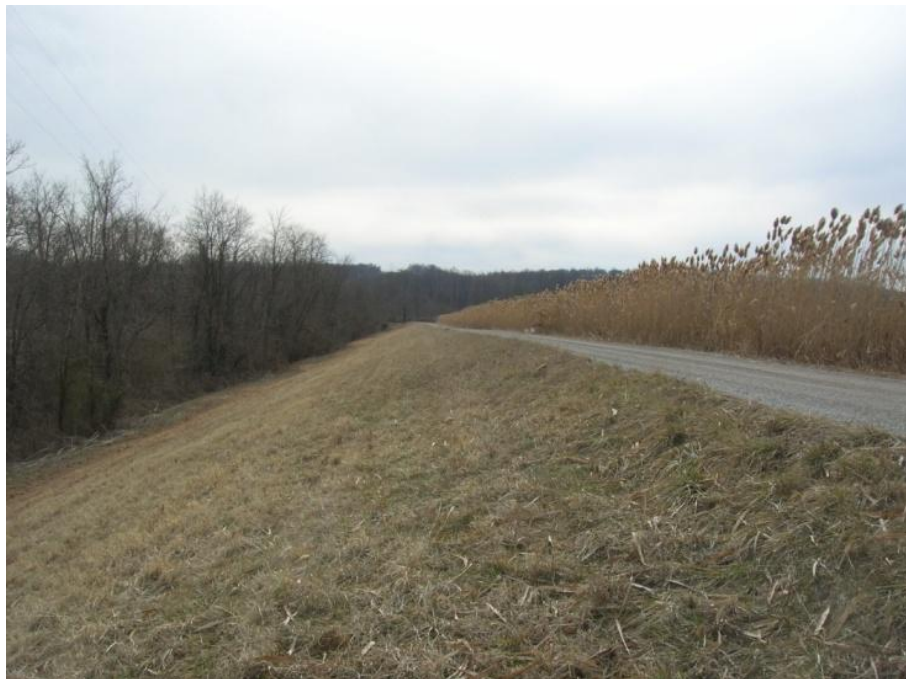
Figure 5.2.1.3: Looking down E Crest from NE Corner; Typical Conditions

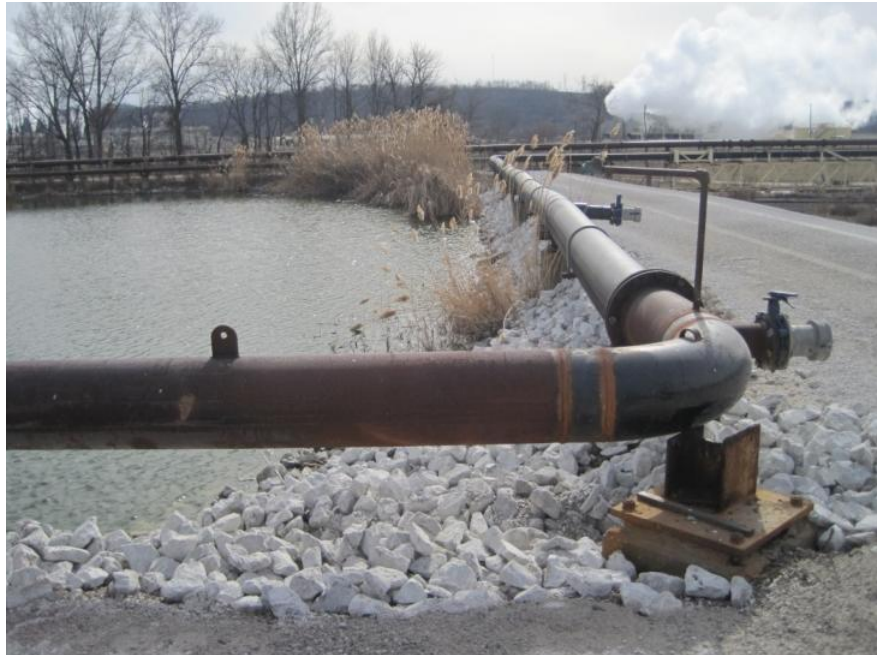
Figure 5.2.1.4: Looking down W Crest from NW Corner; Typical Conditions

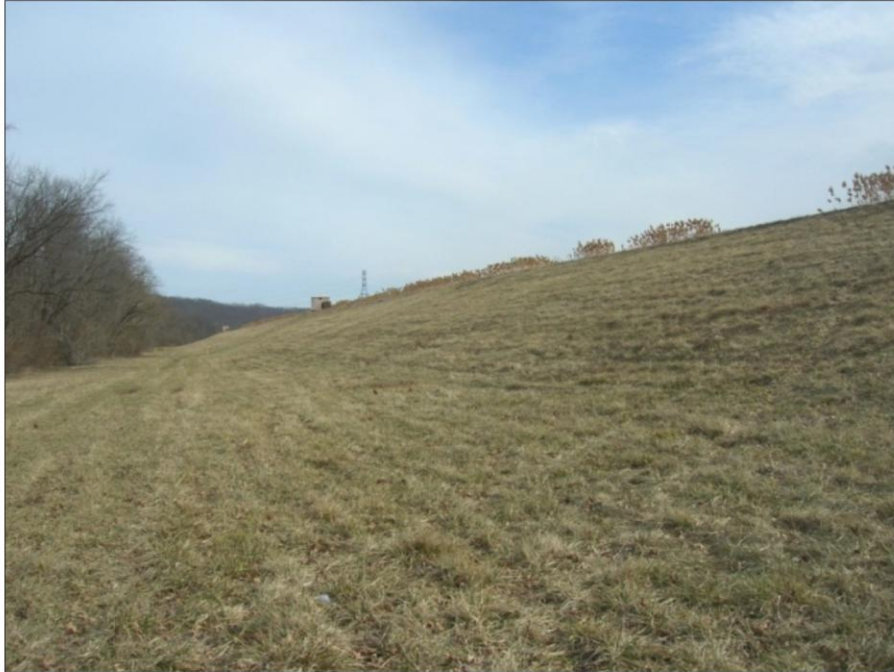
The outside slope of the south and east dike are bordered by parallel ditches that drain to the Ohio River. The outside slope of the north dike runs parallel to and faces the Ohio River. The outside slopes were observed to measure approximately 3:1 with some variances. The exterior embankments were generally in good condition with adequate grass cover and well maintained (See Figures 5.2.3.1 through 5.2.3.4 for the general condition of the North, South, East, and West exterior embankments, respectively). There were no observed scarps, sloughs, bulging, cracks, depressions, or other indications of slope instability or signs of erosion found during this assessment.

Figure 5.2.3.1: N Exterior Embankment

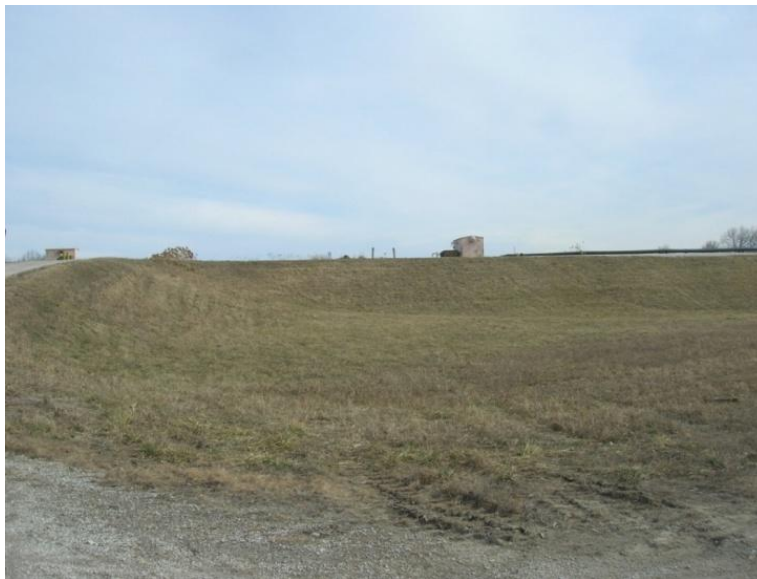
Figure 5.2.3.4: W Exterior Embankment

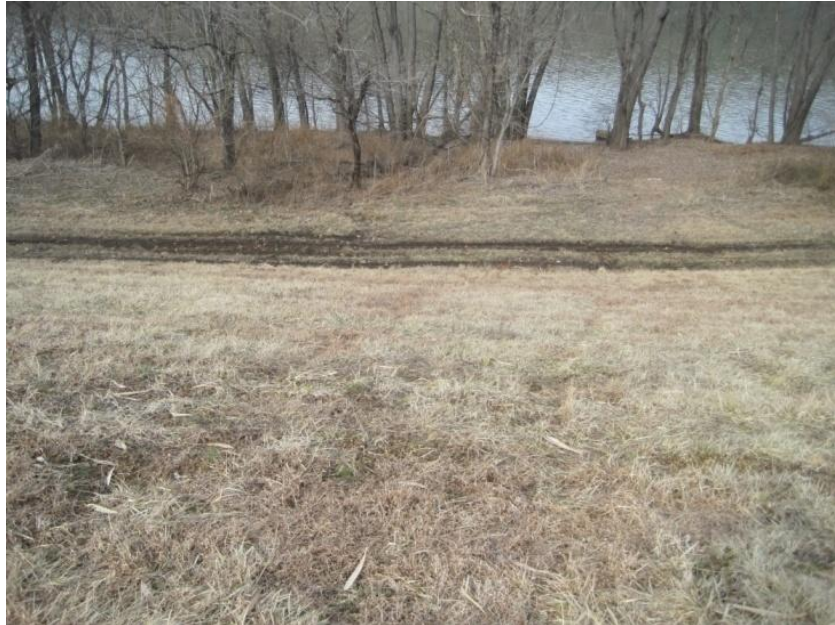
Wet areas were observed at two locations during observations of the exterior slopes along the north dike. Section 5.2.3 addressed this observation further.

As discussed further in Sections 1.1.5, 1.2.1 as well as 1.2.2, wet areas were observed in two locations during observations: one at the toe of the exterior slope along the north dike (See Figure 5.2.3.5), and one in the southeast corner of the outside embankment that appears to be associated with the adjacent ditch running parallel to the east dike as well as the ditch parallel to the railroad/ south dike, intersect coincidently with the beaver habitat, thus water accumulates from the dams constructed by the beaver

Figure 5.2.3.5: Observed Area at Toe of Exterior Slope of North Dike

- As recommended within the S&ME Instrumentation Report's recent recommendations (See Appendix A, Doc 03), all of the instruments are to be checked on a quarterly basis at a minimum.
- Maintenance staff at the plant should continue to monitor the area in the southeast corner of the outside embankment associated with the adjacent ditch along the railroad and possible beaver habitat in the area as well as the toe of the northern embankment as mentioned in Section 1.1.5 and 1.2.1, for signs of flow, leaks, or change in water color or clarity.

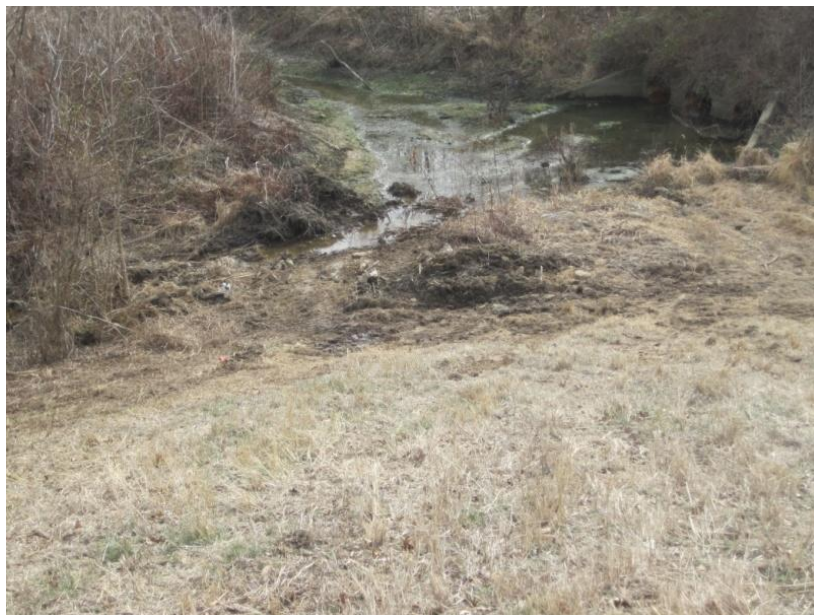
Embankments appear structurally sound. There are no apparent indications of unsafe conditions or conditions needing remedial action. There was, however, some concern about past beaver habitation in/near the bottom of the southeast corner of the impoundment (See Section 5.2.3 for Figures). The beaver dam had recently been removed at the time of Dewberry's visual assessment.

habitation, slowing drainage to the Ohio River (See Figures 5.2.3.6 and 5.2.3.7). Recent precipitation suggests that these locations are susceptible to the ponding of water from natural run-off and not indicative of leaks or seepage from the Spurlock Ash Pond.

Figure 5.2.3.6: Area Observed Near Toe of SE Corner of Outside Embankment

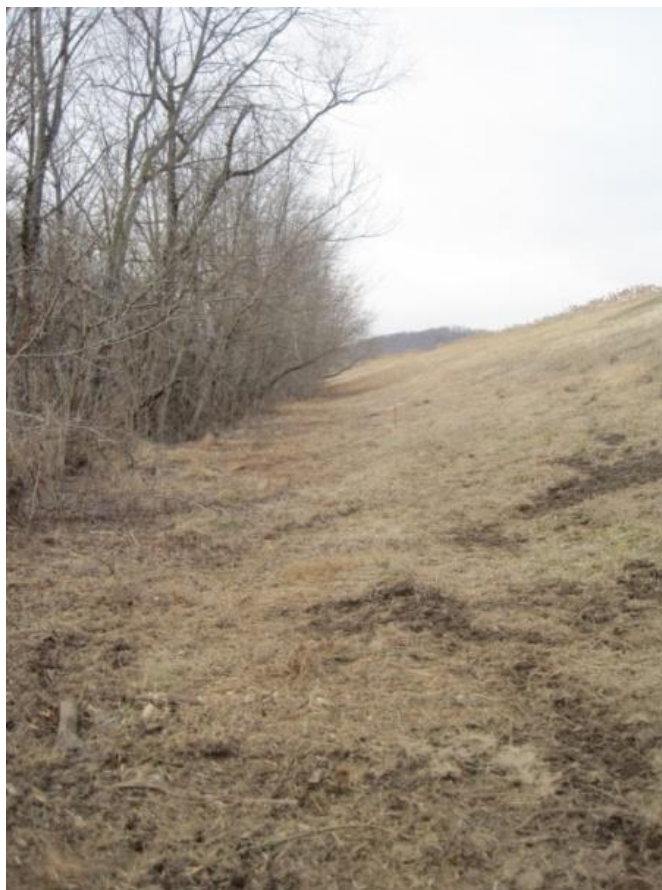
Figure 5.2.3.7: Area Observed Just West of Toe of SE Corner of Outside Embankment

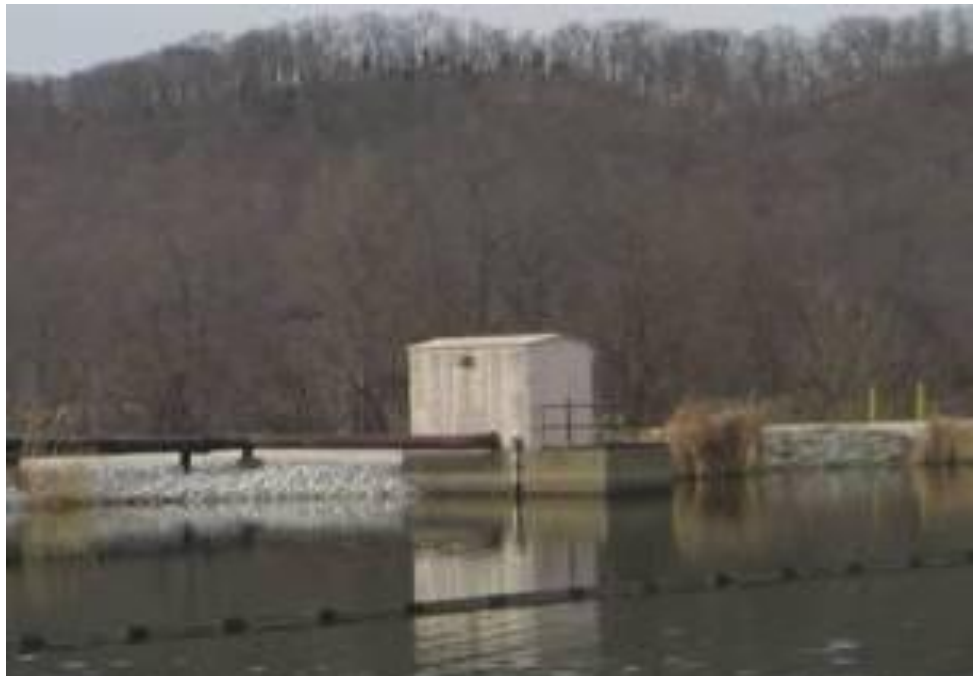
Note also that there is no emergency spillway, the water level within the pond is maintained using an ash water transfer pump station, as seen in Figure 6.1.2.1, capable of discharging at a rate of 4800 gpm.

Figure 6.1.2.1: Ash Water Transfer Pump Station

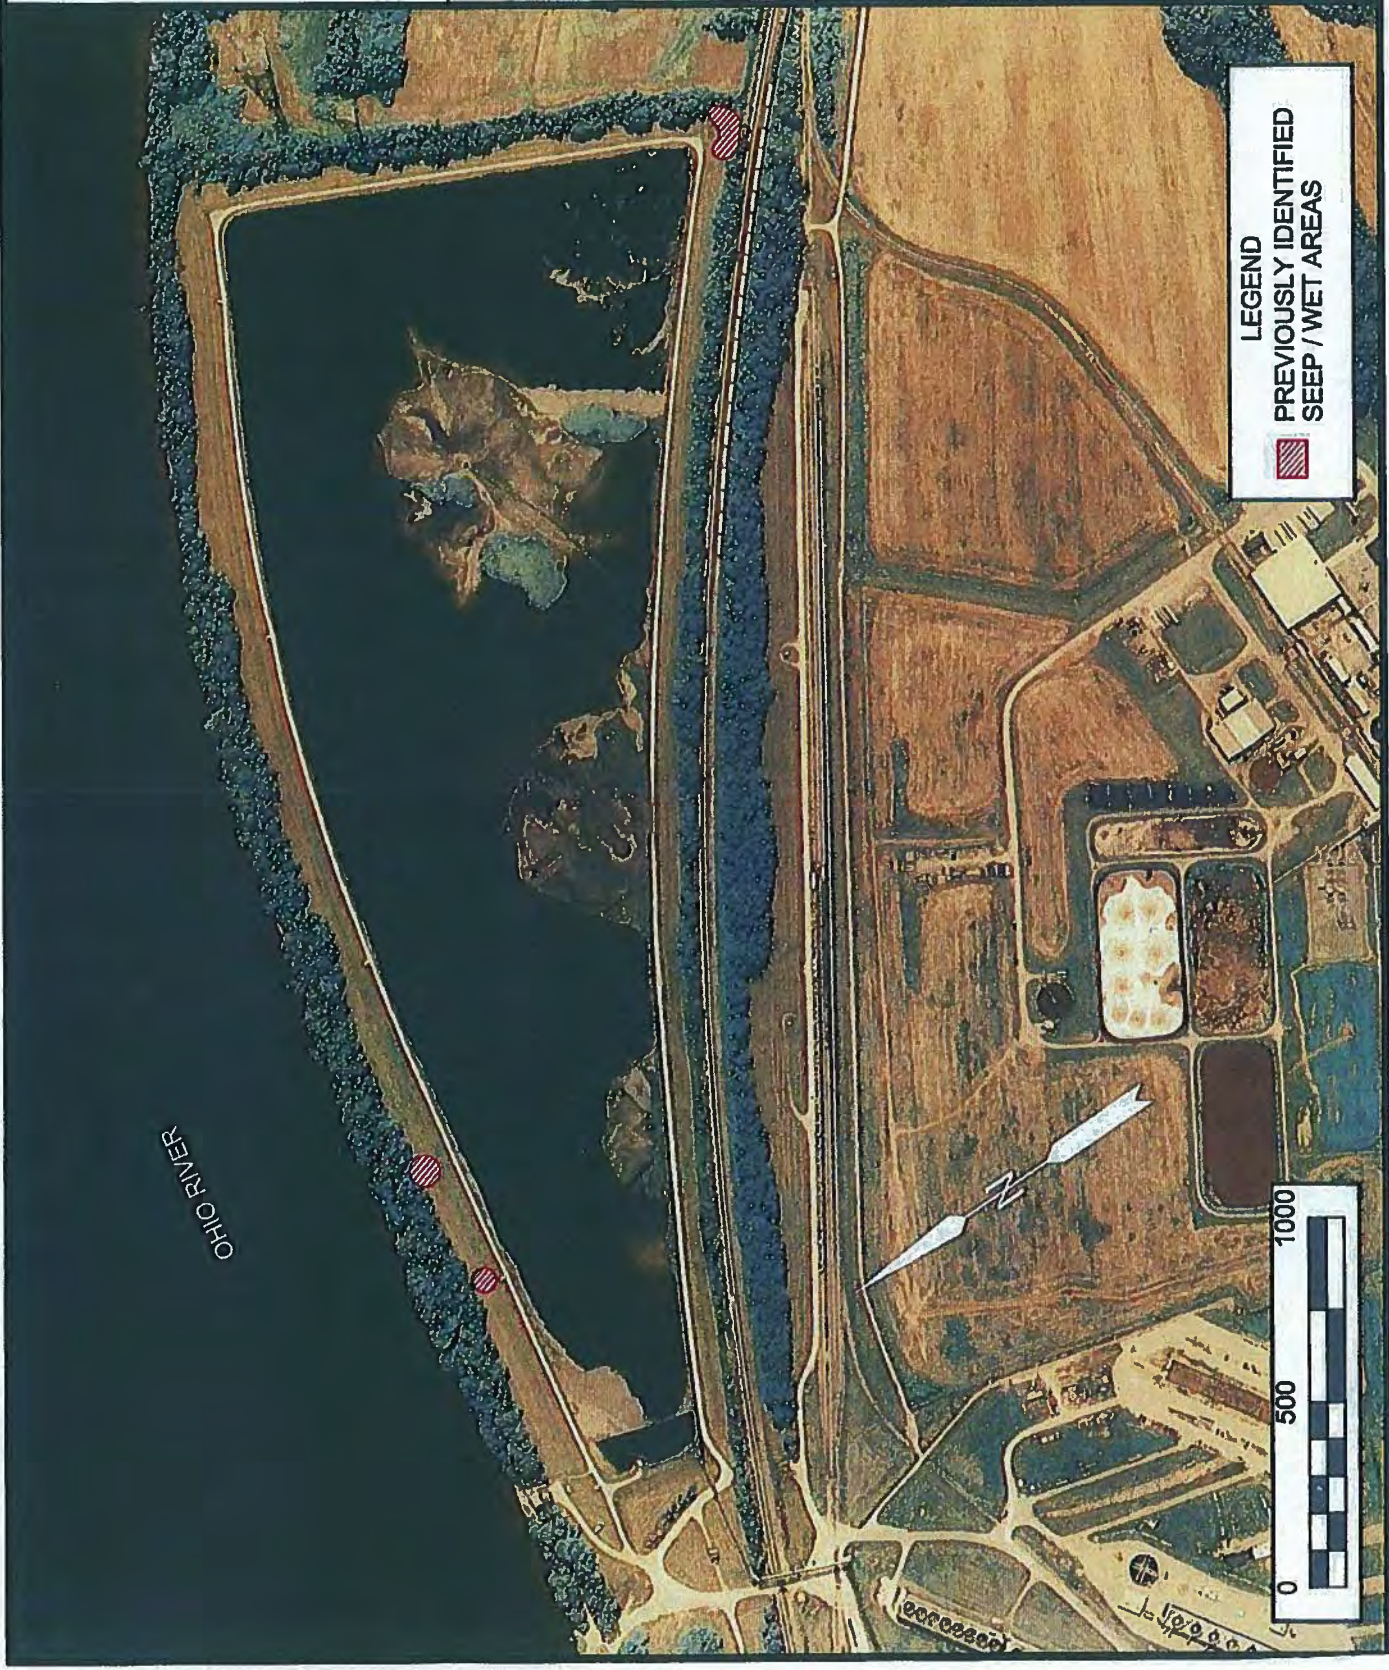
FIGURE
2

PREVIOUSLY IDENTIFIED
SEEP / WET AREAS
